Manhole Inspection Summary

Manhole # S43II_054MH

Insp Date: **3/11/08 3:05 PM**

Location Address: **1630 BOND ST**

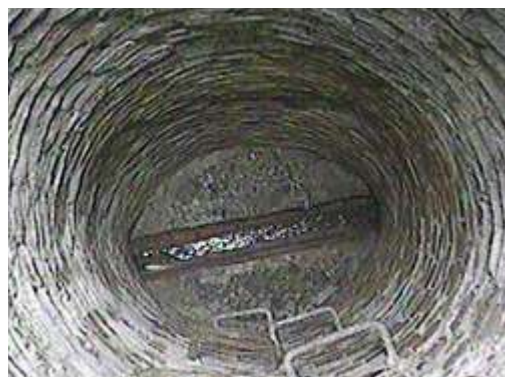
Defect 1

Steps Count: **7** Missing: **0** ☒ **Corroded**

STEPS CORRODED

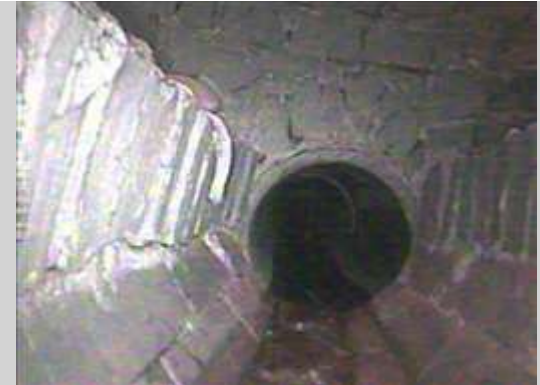
12 O'Clock Outflow

8 in. Circular Gravity Sewer
Pipe Out @ 12 O'Clock

Pipe Height: (in.) Direct
Pipe Material: **Clay** ☐ Pipe Lined
Invert Depth: **13.28** (ft.) Flow Characteristics: **Fast**
Deposits: ☒ None ☐ Mud ☐ ~~Gravy~~ ☐ **Debris** ☐ Grease
Silt Depth: (in.) Deposits Extent:
Infiltration: **None** Pipe Seal Cond: **Sound**

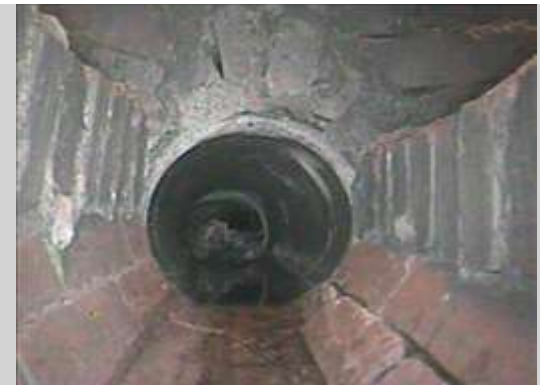
6 O'Clock Inflow

8 in. Circular Gravity Sewer
Pipe In @ 6 O'Clock

Pipe Height: (in.) Direct
Pipe Material: **Clay** ☐ Pipe Lined
Invert Depth: **13.25** (ft.) Flow Characteristics: **Fast**
Deposits: ☐ None ☐ Mud ☒ ~~Gravy~~ ☒ **Debris** ☐ Grease
Silt Depth: **0** (in.) Deposits Extent: **Light**
Infiltration: **None** Pipe Seal Cond: **Sound**
